Restoration Values: Methodology, Historic 1906 Masonry Structure

RESTORATION VALUES: A 1906 BRICK RESIDENCE

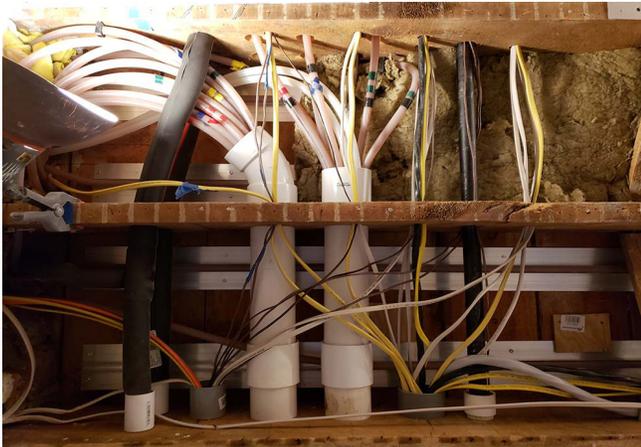
Figure 3. Heating (radiant panels), plumbing, electrical, and controls.

Removal of the partial basement ceiling and first-floor ceilings provided space for the installation of drain, waste and vent piping, cold and hot water feeds, space for 8-zones of radiant heating piping, aluminum heat-transfer pans throughout, gas piping, thermostat control wiring, bathroom exhaust piping, and sound insulation.¹⁴ Recessed LED lighting was installed throughout. Ceiling plaster was replaced with 5/8-inch finished sheetrock.¹⁵

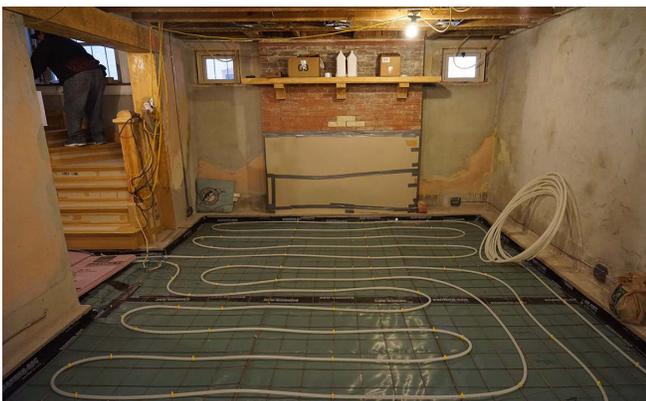
Figure 4. Heating (in-floor radiant) w/ sub-floor radon control.

The basement floor was excavated one-foot to allow the installation of sub-floor radon collection piping installed in a pea gravel base. The plumbing DWV waste system was installed below the gravel bed to permit the installation of a bathroom on this level. A copper water service (2008) replaced the lead pipe to the city street shutoff. A chemically inert vapor barrier was installed just below a reinforced four-inch concrete floor. A two-zone radiant heating system was installed within the concrete floor. Finally, the concrete floor was polished and sealed.

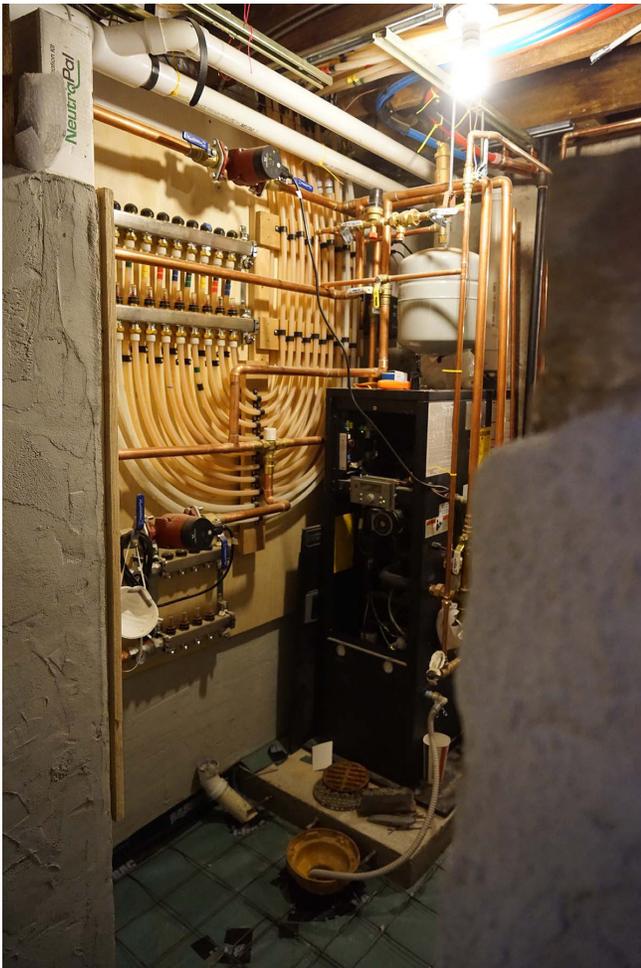
Figure 5. HTP condensing boiler, manifold, and controls.

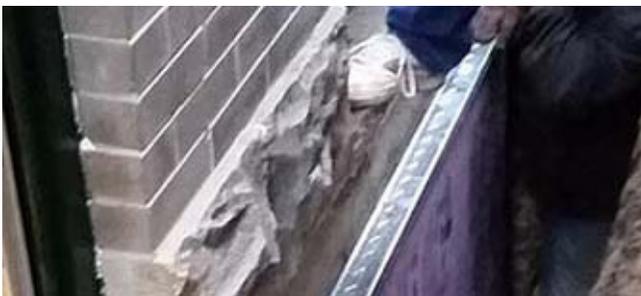
Figure 6. 2-inch rigid polystyrene below-grade perimeter insulation & drainage.
