Permanent? Ageless? A Case Study of the Pulitzer Arts Foundation in St. Louis

LIANE HANCOCK

This paper endeavors to relate the ongoing preservation and adaptability of the Pulitzer Arts Foundation to observations on how permanence is viewed within the built environment both in Japan and the United States. It presents best practice protocols for both preservation and maintenance including measures that were taken during construction to ensure the building would remain ageless.

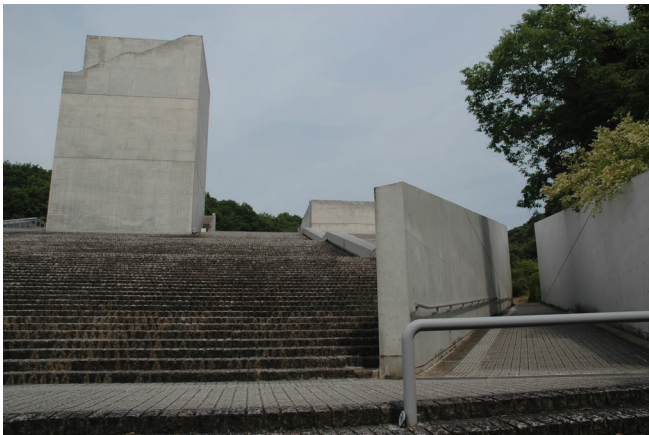
Figure 3. Chikatsu Asuka Museum, Osaka, Japan, 1994. Copyright Liane Hancock, 2017.

Across history, Japan has felt China’s long shadow. For many decades, acid rain from coal-fired power plants has traveled from mainland China, blanketing Japan. In addition to effecting flora and fauna denitrification and sulfate absorption erode material surfaces, in particular stripping cement from the surface of concrete. This chemical action reveals the sand and rock aggregate that lays directly below. A building such as Ando’s Water Temple in Hyogo Japan, built a mere twenty seven years ago, has lost its dense smooth surface in locations where rain water pools or runs down the surface of the building (figures 1 and 2). Once the surface is removed organic materials and inorganic pollution collects on the surface causing discoloration. For example, the pristine exterior surfaces of the Chikatsu Asuka museum, completed in 1994, now exhibit a definite patina (figures 3 and 4).

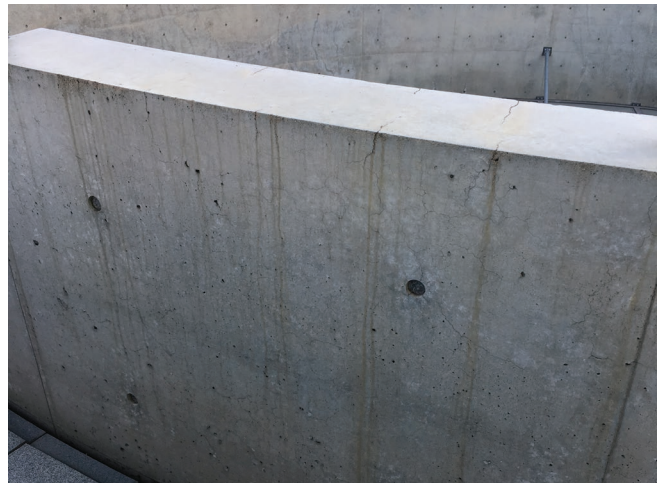
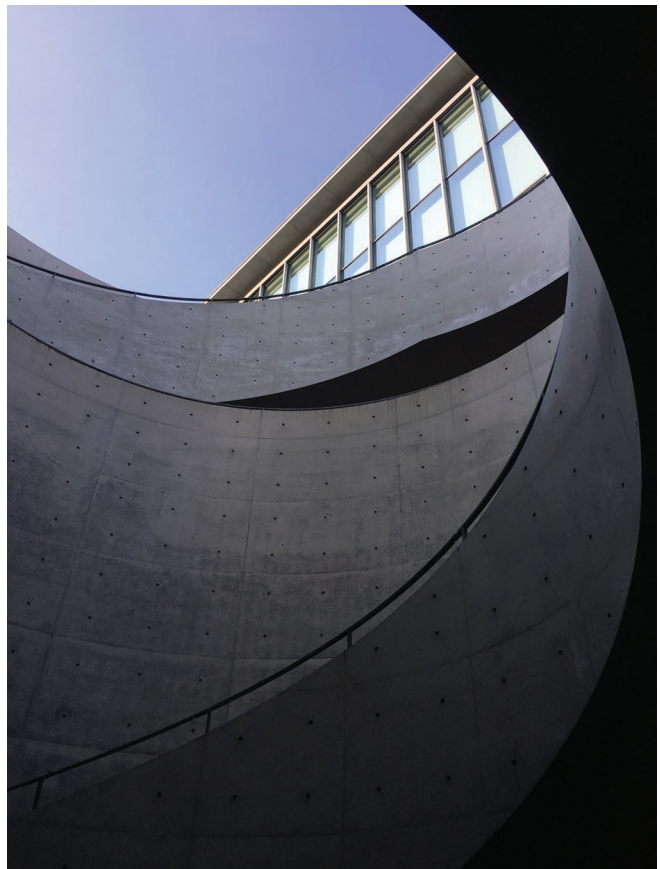
Figure 5. Hyogo Prefectural Museum of Art, Kobe, Japan, 2002. Copyright Liane Hancock, 2017.

The marine environment of Japan exposes reinforced concrete constantly to airborne chloride. Depending upon the length of time the concrete remains moist, chloride from salt water in the air penetrates the surface. The acidic character gradually increases pore size on the surface; capillary absorption provides infiltration; and once deep enough steel reinforcing corrodes. Corroding steel provides internal pressure on the concrete, causing cracking.⁵ Consistent chloride exposure in conjunction with settlement has caused spalling in many of Ando’s projects located along coastal Japan (figure 5).

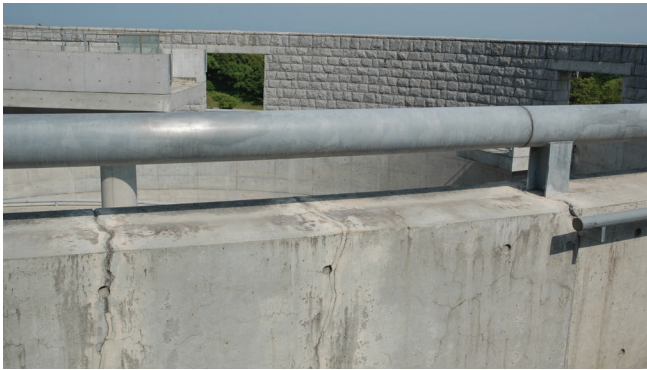
Figure 6. Awaji Yumebutai Conference Center, Awaji, Japan, 2000.
Copyright Liane Hancock, 2017.

In Japan, tradesmen have historically cast Ando’s buildings in continuous pours. There are no expansion joints or control joints. The only delineation on the surface is the refined pattern left from the edges of the formwork. Within Japan, for many years, prevailing wisdom taught that uninterrupted reinforced concrete foundations were the best way to resist earthquakes.⁶ Additionally, control and expansion joints interrupt the aesthetic emphasis on the simple taut surface of Ando’s architecture. Across Japan, buildings such as the Awaji Yumebutai Conference

Center, completed in 2000, show extensive cracking (figure 6). The site for the conference center was a quarry for Kansai Airport in Osaka Bay and Ando’s enormous project extends across and caps the hillside. Without expansion or control joints, the concrete has failed in numerous locations. No attempts at preservation have been made. Over time, the conference center has grown less popular and in another decade a similar building, by an anonymous architect, would typically be demolished.

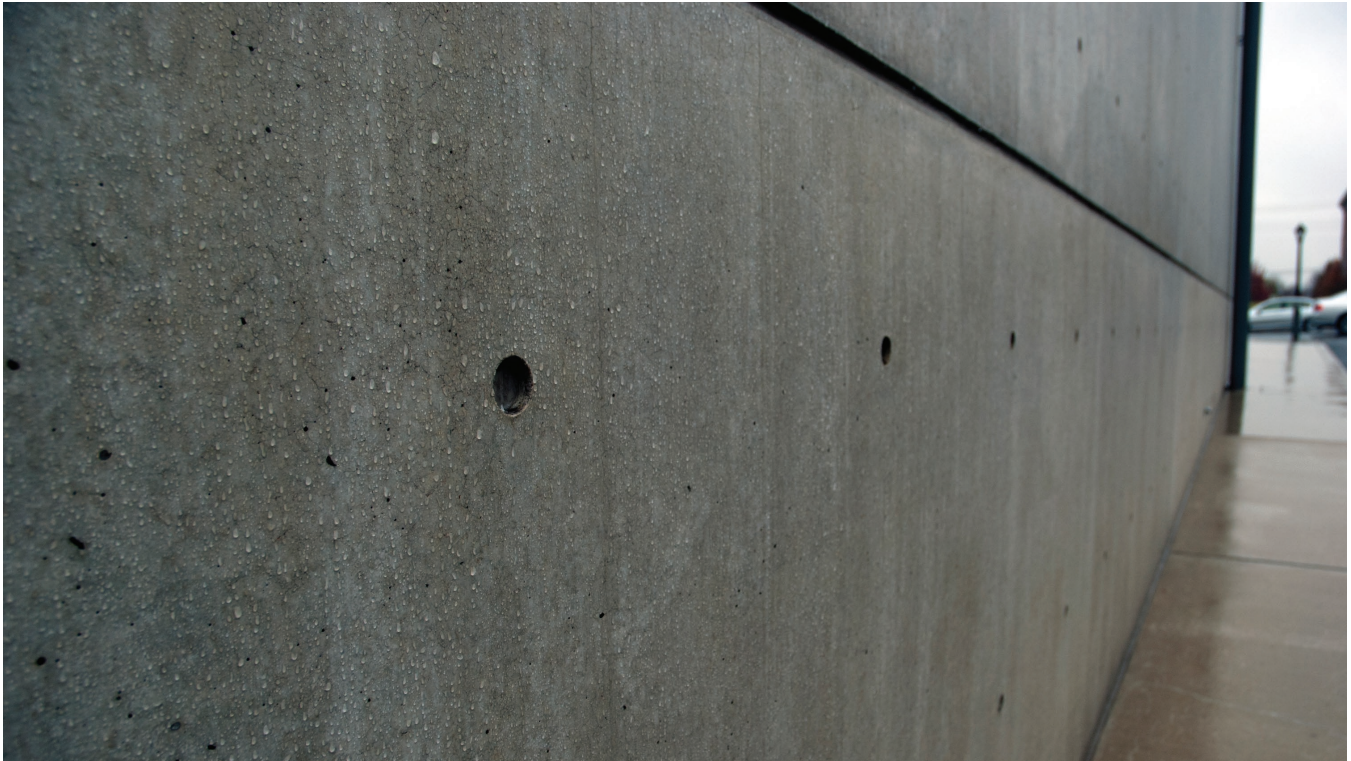
Figure 7. Pulitzer Arts Foundation, water being repelled by sealer. Copyright Liane Hancock.

On a building this durable it is difficult to conceptualize that the smooth outer surface is only a fragile layer of cement paste. If unprotected, wind, sun, and weather could easily erode that layer. To maintain Ando's characteristic smooth surface in perpetuity, the design and construction team developed a sealant protocol very early in the design process. The sealant protocol began with a curing compound applied directly after stripping the formwork. Next the team applied a cyloxine sealer with a silicone base as a two week bridge sealer. Because the walls were still curing there was too much water in the walls to allow full penetration, but the surfaces were protected. The final sealer was then applied:

pure silicone. As Steve Morby explains, "A silicone molecule is 1/10th the size of a water molecule. As the water evaporated from the surface of the wall, microscopic holes the size of water molecules were left. The silicone bonded with the Portland cement. This made the holes 9/10th the size of a water molecule. By decreasing the size the water molecules could not fit any more. There was no room. If you sprayed the wall with water it just beaded on the surface."

After completion of the building, the Pulitzer adopted an ongoing maintenance sealer protocol using a latex based sacrificial graffiti sealer designed for stone. The sealer protects against any kind of foreign materials on the surface and provides UV and weather protection. Initially the sealer was to be applied every five years, but because the Pulitzer's surface is so dense the sealer could not penetrate as deeply as it did in the manufacturer's laboratory testing. The concern over preserving the surface has been so serious that the entire building is sealed each year (figure 7).
