Lessons from Léogâne: Case Studies From Haiti

Mark Taylor

University of Illinois at Urbana-Champaign

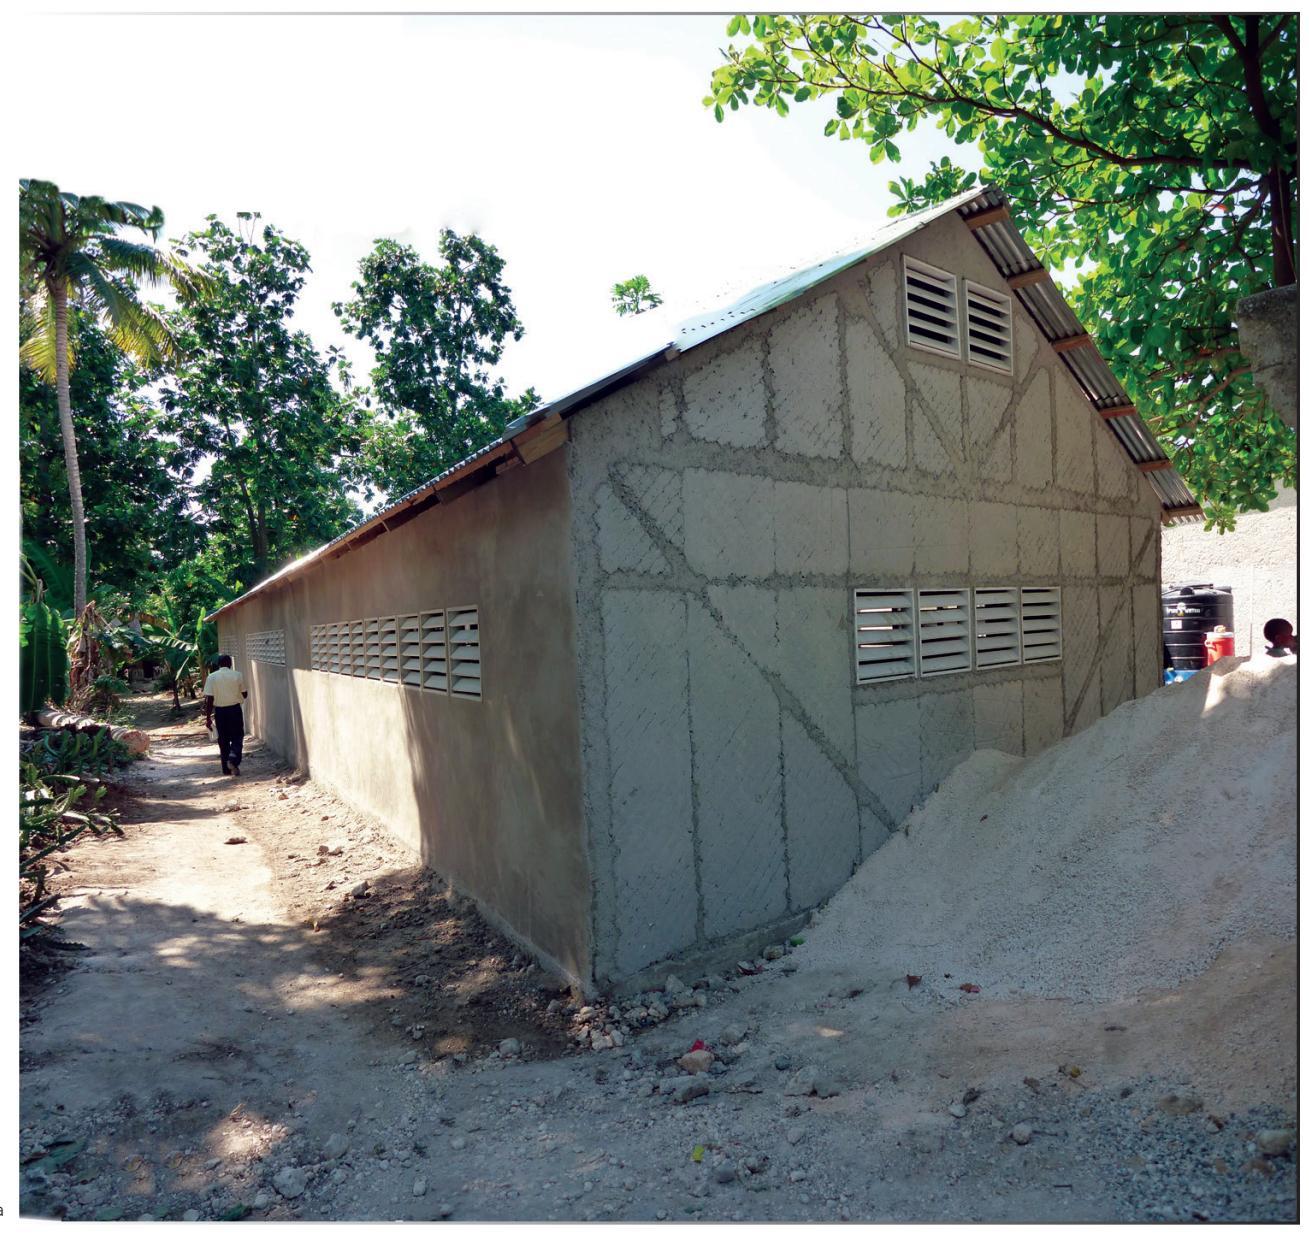
2a

Figure 2 and 2a: Temporary School Constructed by Volunteer Labor.

The construction methods used by All Hands were very suitable for those with limited construction knowledge. The system was light and ductile in nature and drew on vernacular building practices, while adding structural rigor. The walls of the schools were formed with 2x4'' stud framing, anchored to a concrete slab with bolts. The roofs were formed from wooden trusses with large gusset plates secured to the studs with hurricane straps. An innovative stucco treatment was applied to the walls. Chain-link fence

served as a lath. It was secured to the stud walls, before removable formwork was attached to the outside of the building. A mix of sand-cement stucco was applied to the lath by hand in a manner similar to traditional parge applications that have been applied on modest structures in Haiti for generations (see figure 2). A second finished coat applied with a trowel and float completed the inside, before the exterior formwork was removed. The 3/4" base coat provided enough of a key for a finish coat to be applied on the outside of the building (see figure 2a).

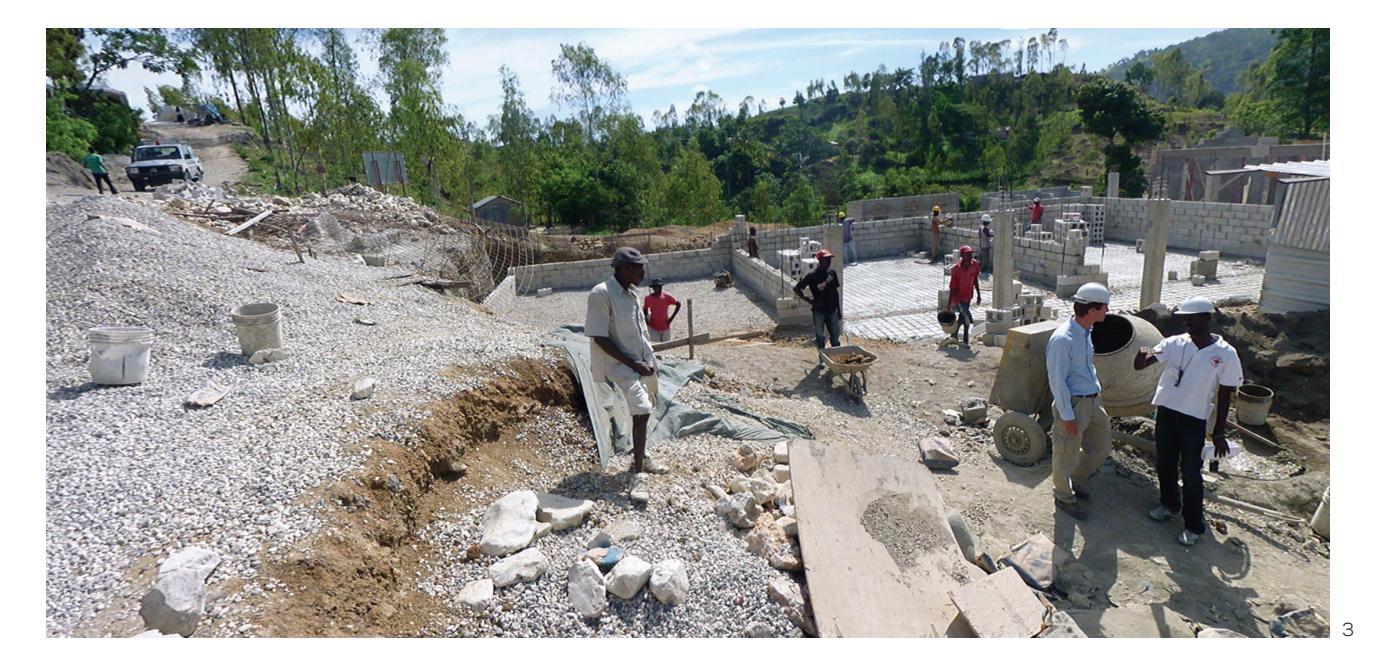
Figure 3: École National Fond de Boudin under construction with oversight from American Architect and Haitian Engineer. professionals were appointed to complete a building designed to last a minimum of fifty years.

As part of the bidding process the Spanish Red Cross required each potential contractor to perform a number of tests to ensure they could identify critical details on drawings, estimate quantities of building material, and work safely. In addition the Red Cross hired Haitian engineers to be on site every day during the construction of the schools they were financing. These engineers gained valuable experience overseeing the construction of a well-engineered building. Their work in turn received the oversight of the American architectural project manager, and Spanish engineers. This model for reconstruction sets the highest standards. The design and engineering of the building complies with internationally recognized building codes, the next generation of local engineers receives valuable onsite experience, and the main contractor is trained in best construction practices (see figure 3).

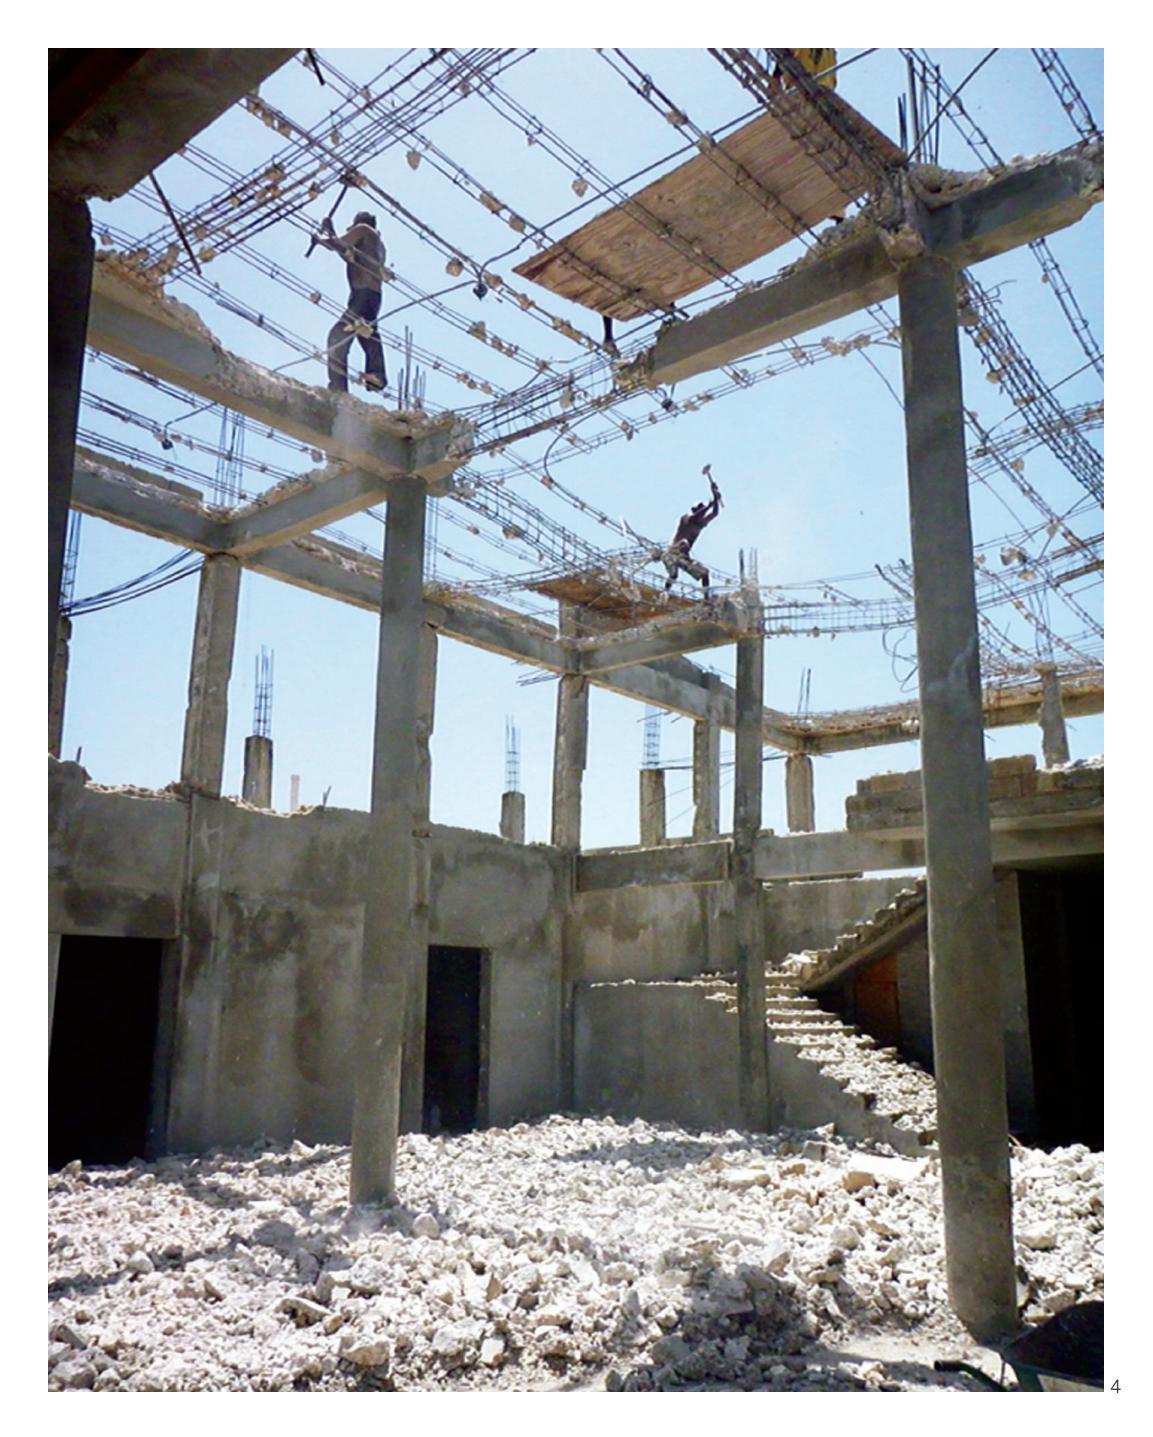
Figure 4: Partialy collapsed hospital being demolished by original construction crew.

The Kay Fanm Yo was built less than a hundred feet away from the partially collapsed hospital. The remnant of which exposed numerous inadequacies that are common in many structures built in Haiti. The poorly constructed columns of the hospital, and the limited availability of skilled labor, gave the designer little confidence that a building reliant on column and beam

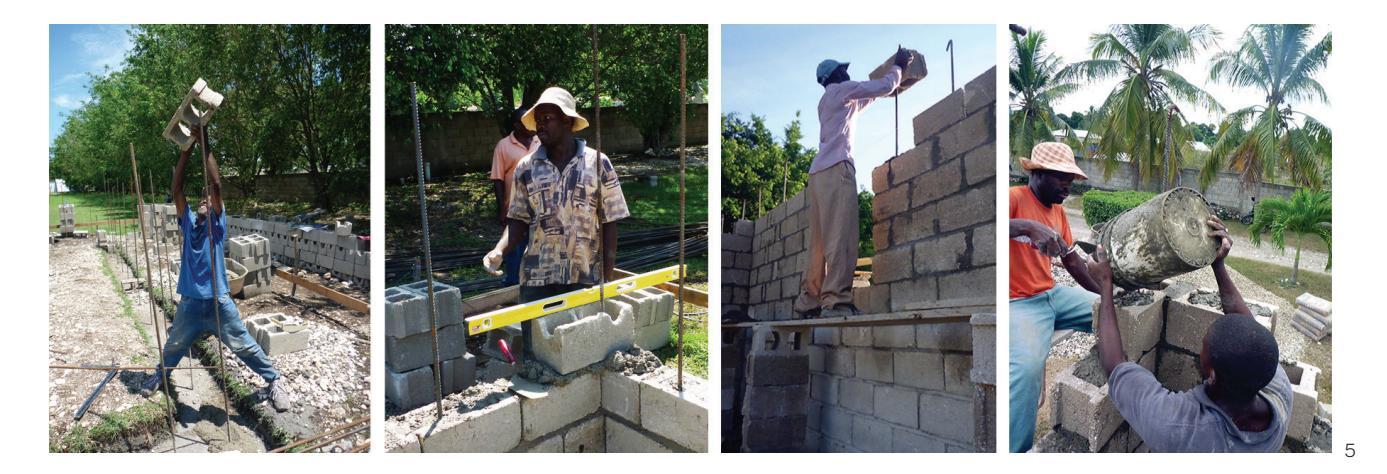
Figure 5: Construction of the Kay Fanm Yo (Women's House). Reinforced masonary construction to resist local siesmic and high wind hazards. Finally, the gap in earning potential between the most affluent and the poorest in Haiti has to be addressed, if a resilient community is to emerge from the catastrophe of 2010. It is unreasonable to expect a worker to consider a hazard that may occur biannually, or every fifty to one hundred years, if his daily concern is whether he can earn enough to feed his family. This adjustment will require societal changes beyond the realm of architecture. However, if change does not take place, Haiti's re-building efforts will take lives in a similar way the built environment failed the nation in January 2010.

The foundation of the Kay Fanm Yo was dug by hand, and re-bar carefully set, to ensure it would sit vertically in the middle of a cell in each required bloc. This was possible with careful measuring and close supervision. To reduce the quantity of re-bar required and to provide a strong connection, only one overlapping splice for all vertical rebar was specified. The required overlaps of a No.4 bar and a No.5 bar are 28" and 36", respectively. There was a concern that the masons would have difficulty lifting a CMU high enough to thread it over the re-bar. The 7' lift was higher than the masons were used to, but it was achievable, even for the shortest member of the construction crew (see figure 5).
